NBSIR 84-2949

Advanced Thin Film Thermocouples

October 1984

Prepared for
National Aeronautics and Space Administration
Lewis Research Center
Cleveland, OH 44135

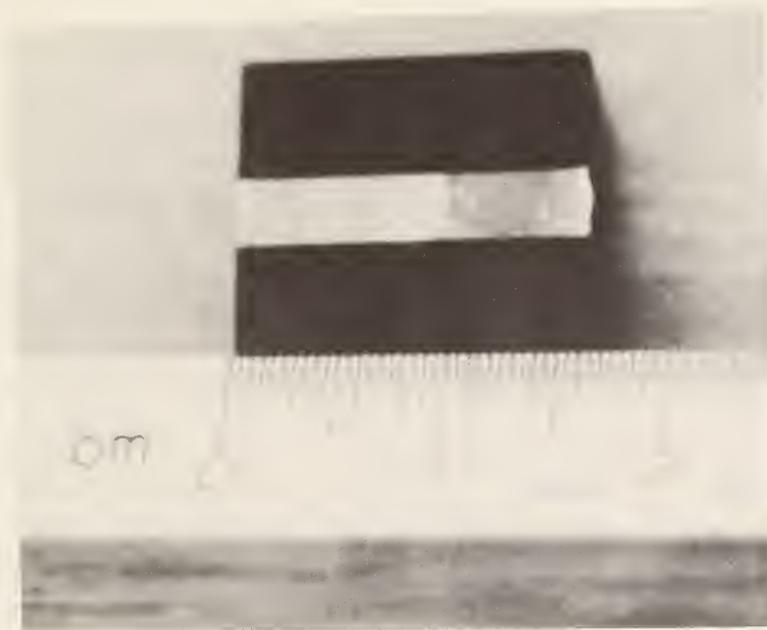
Figure 35. Small test coupon for thin film Pt and Pt 10% Rh

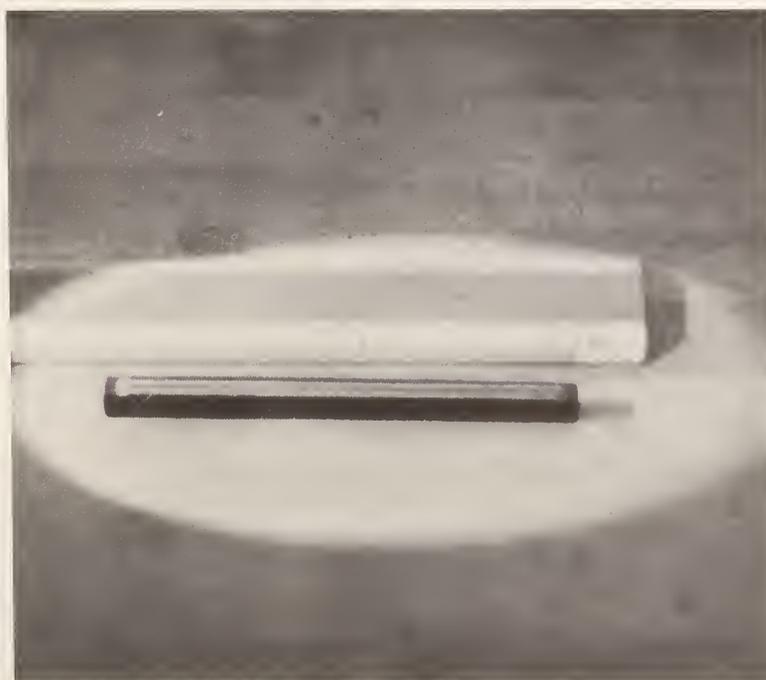
Figure 36. Thin film thermocouple test coupon

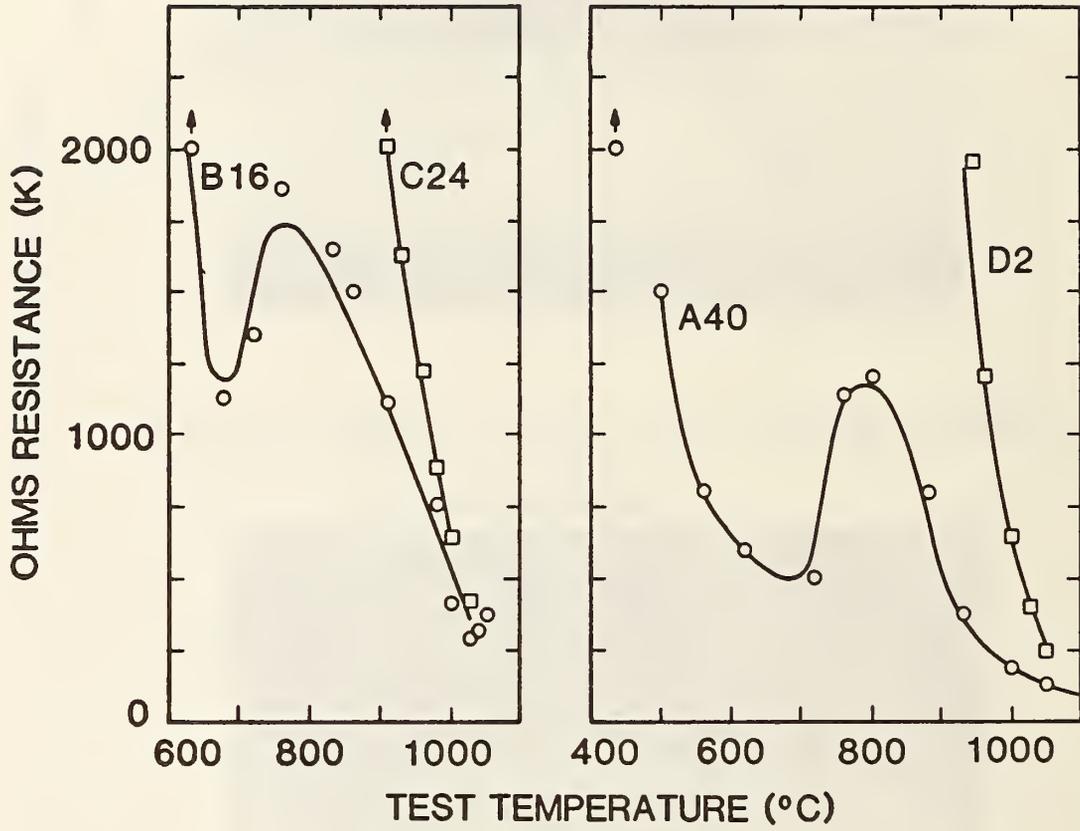
Figure 37. Sputtered oxide film resistance
